Restoration of the Gen. U. S. Grant Birthplace in Pt. Pleasant, Ohio

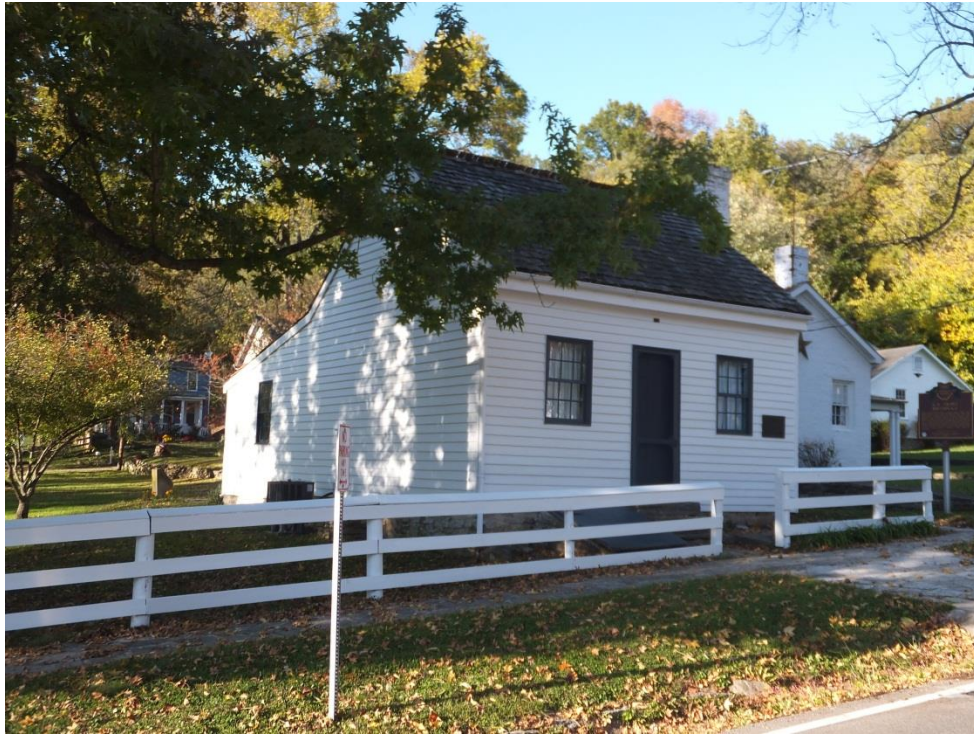
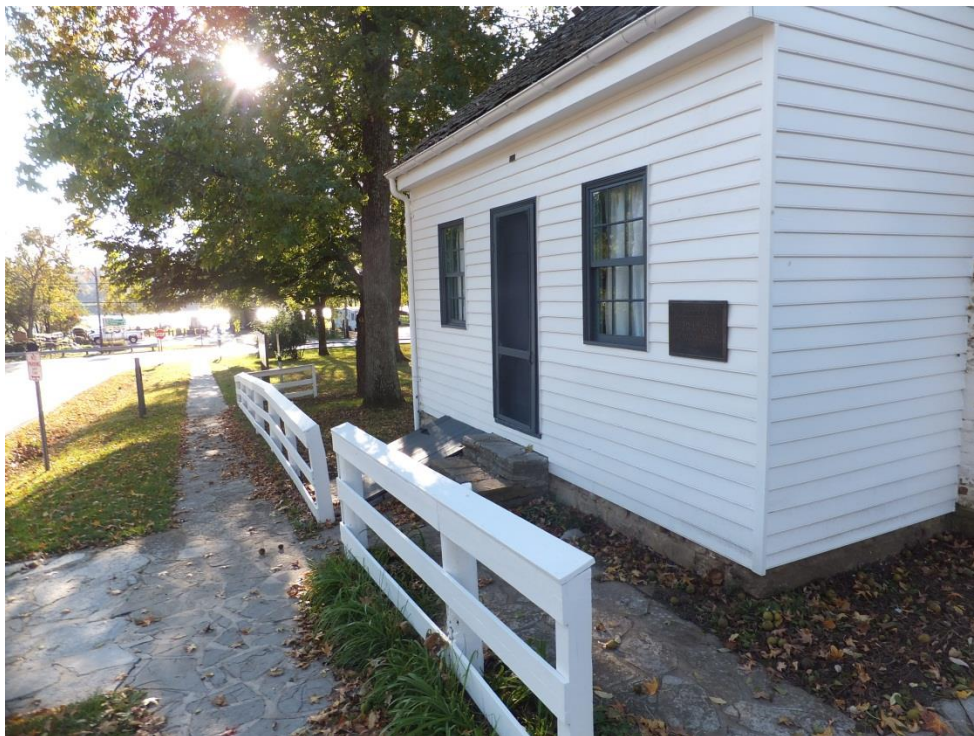
After restoration, including power washing, wood siding and trim repair, window reglazing, bare wood priming, and repainting.

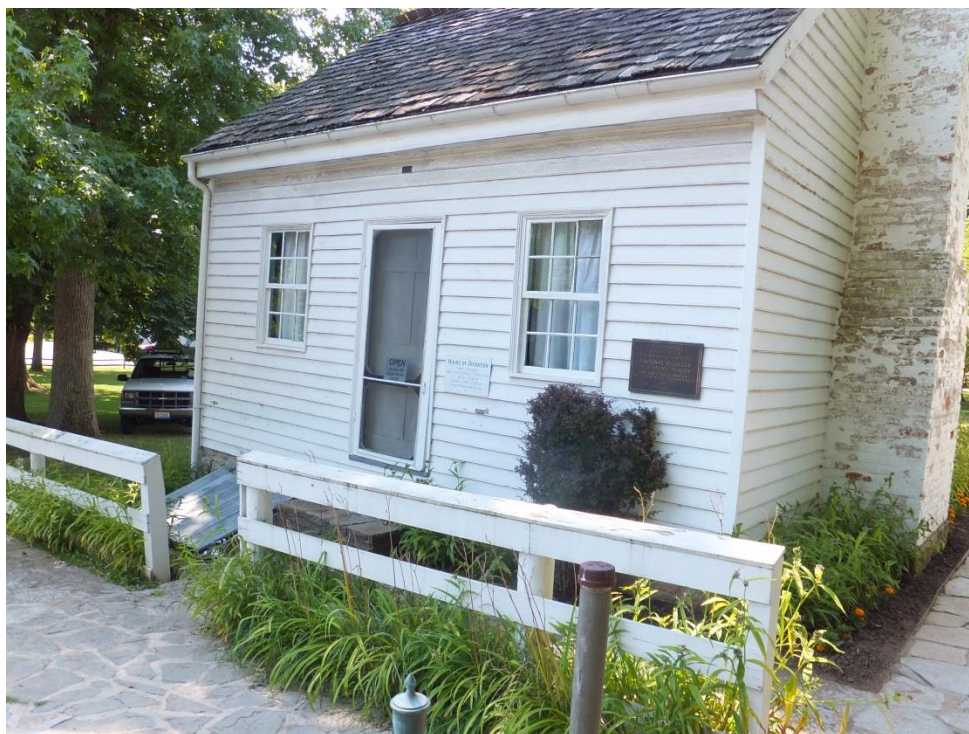
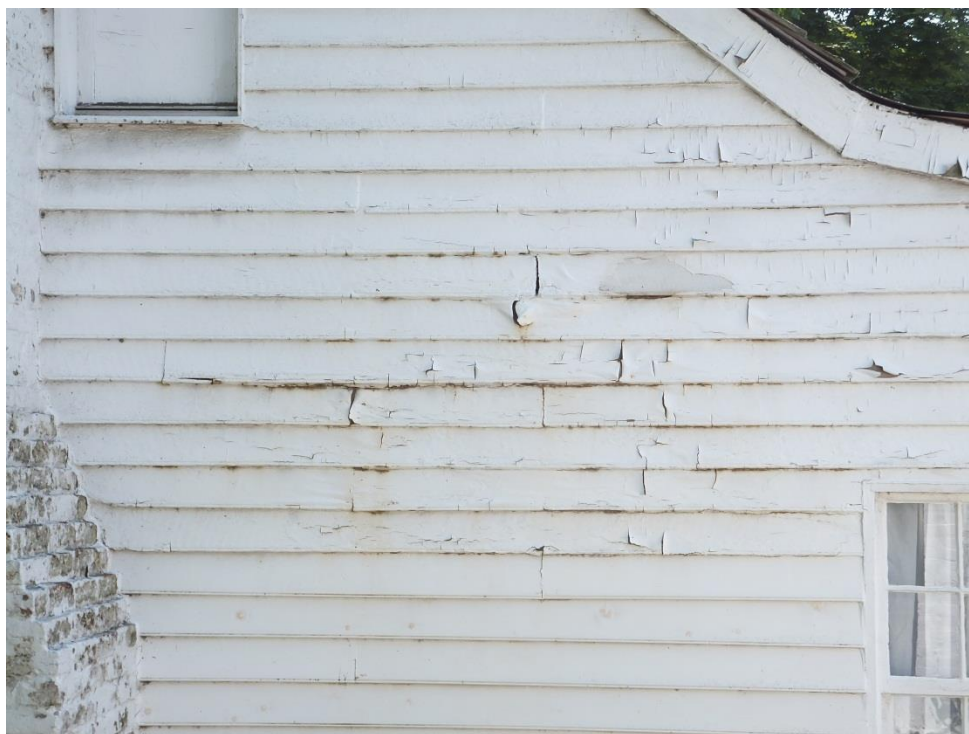
Before restoration, showing peeling paint on siding, railings, doors, and chimney.
